The Adana-Ceyhan Earthquake of June 27, 1998

**Report on the Reconnaissance Mission from July 6 - 12, 1998
of the Swiss Society of Earthquake Engineering and
Structural Dynamics (SGEB)**

Thomas Wenk
Corinne Lacave
Kaspar Peter

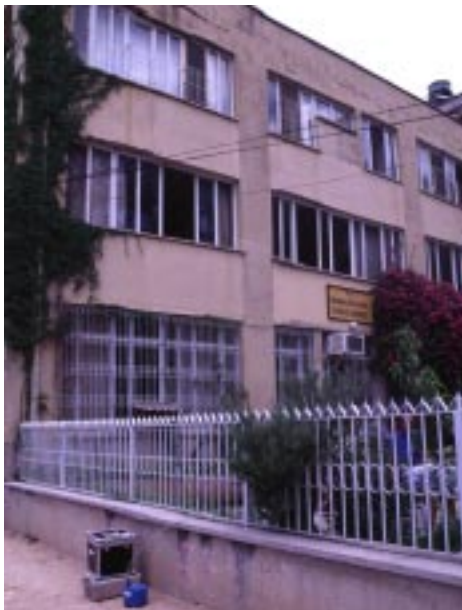
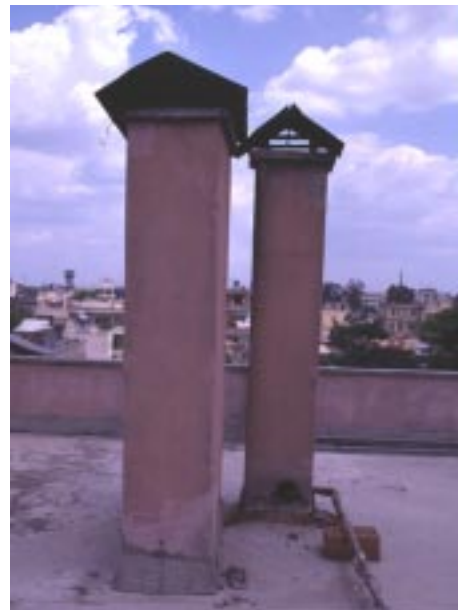
Fig. 3 Front view (left) and roof view (right) of the local branch building of the Agricultural Ministry in Ceyhan (damage grade 1)

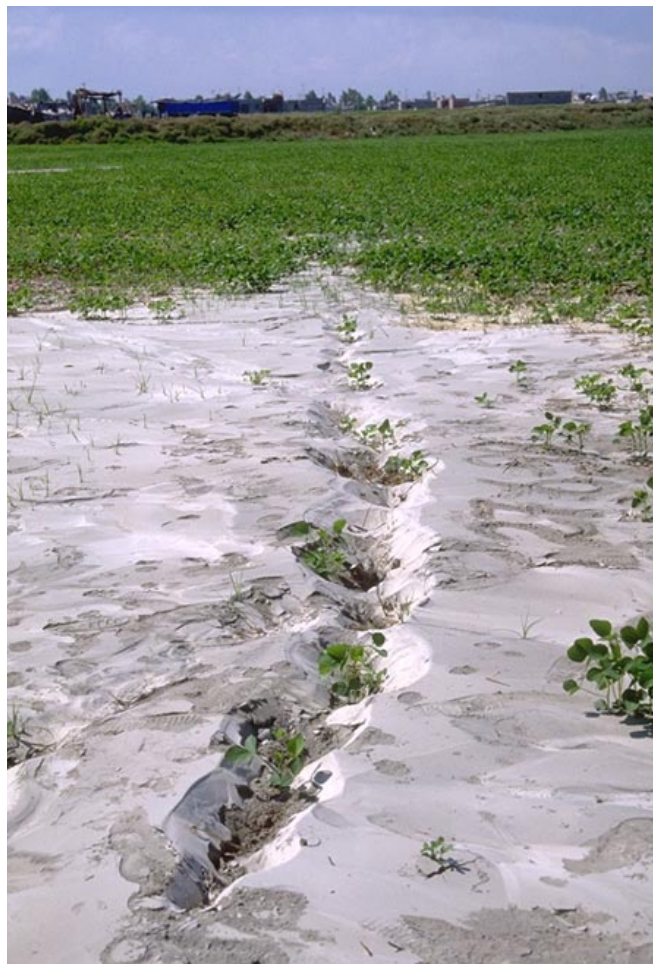
Clear liquefaction traces along the banks of the Ceyhan River were observed west of Ceyhan. This phenomenon is due to the presence of fine-grained alluviums, that liquefied during the main shock, leading to the formation of sand boils in the nearby fields. Fig. 10 presents a picture of one of these cracks, about 10 meters long, through which very thin sandy alluvium particles were pushed up in the plantation fields. This phenomenon is a clear indicator of strong non-linear effects that occurred in this region. Such effects can significantly reduce the peak ground acceleration and should be considered in seismic hazard assessment.

Fig. 10 Sand boils due to soil liquefaction along the Ceyhan River banks, west of Ceyhan

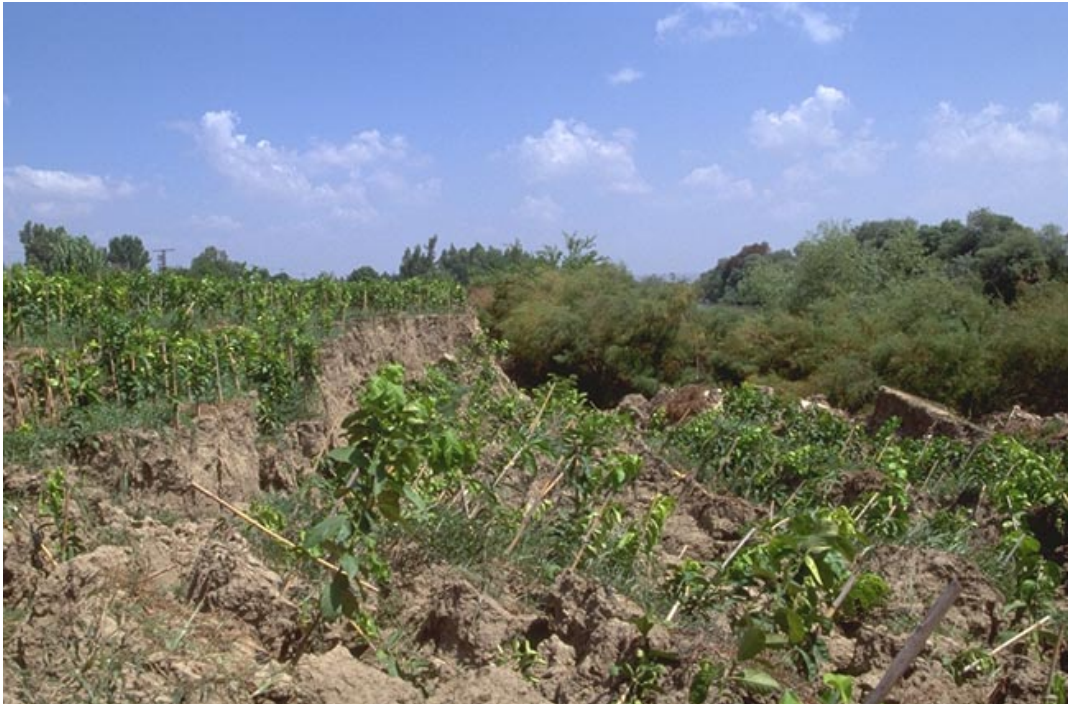
Small landslides, another important soil deformation phenomenon, were observed along the Ceyhan River. Part of a lemon tree plantation, located on the river bank, slid towards the river, as shown in Fig. 11. A vertical subsidence of 2 to 3 m and a horizontal displacement of about 1 to 2 m towards the river were observed. The landslide occurred in recent soft alluvial deposits. These observations confirm the general experience that a very specific soil behavior can be expected particularly in fine-grained recent alluvium deposits, such as river banks.

Fig. 11 Landslide in lemon tree plantation on the Ceyhan River bank, southwest of Ceyhan

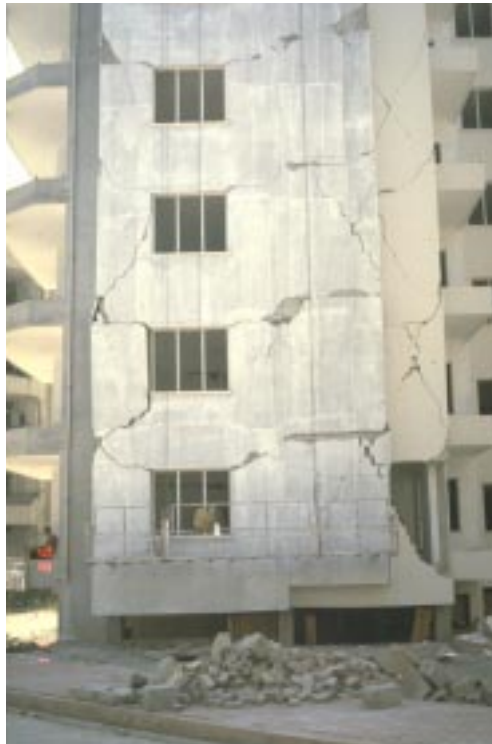
Fig. 12 Typical damage to masonry infills in the form of X-cracks (damage grade 3)

Fig. 12 shows large X-cracks in the masonry infills of a residential building in Ceyhan. In Fig. 13, also a residential building in Ceyhan, the damage is less severe. The cracks follow the joints between the masonry infills and the reinforced concrete frame. This is an indication for the incompatible horizontal deformation behavior of the two building elements.

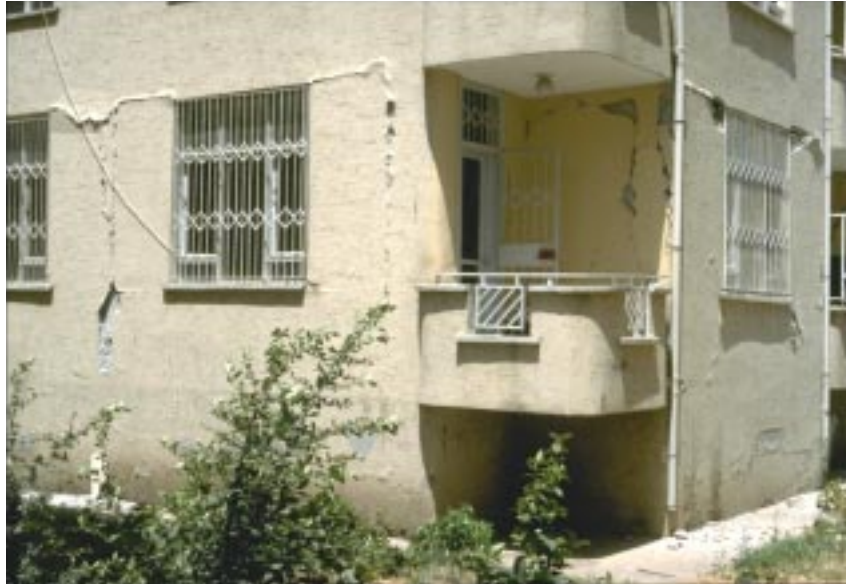
Fig. 13 Cracks between the reinforced concrete frame and the masonry infills showing the incompatible deformation behavior of the two elements (damage grade 2)

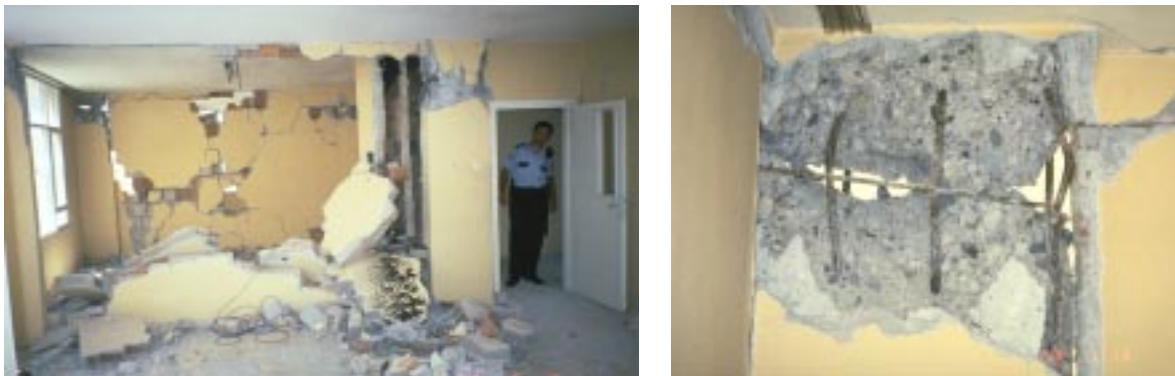
Fig. 14 Total destruction of the masonry infills by large differences between the horizontal displacements of top and bottom slabs (left), detail view of the upper part of the reinforced concrete column (right), (damage grade 3)

The larger the interstory drifts are (i.e., the difference between the horizontal displacement of the upper and the lower slab), the more the masonry infills are damaged, sometimes up to total collapse, as shown in Fig. 14. In this example, the frame columns of reinforced concrete are damaged substantially, while no damage of the slabs was observed.

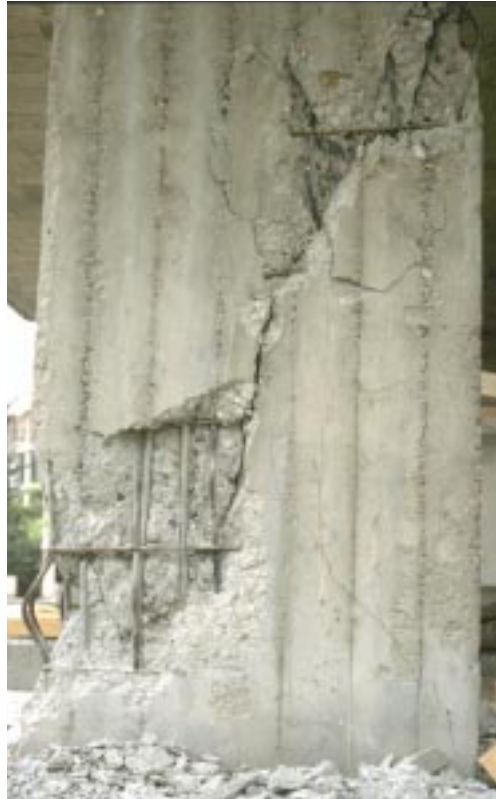
Fig. 15 Shear damage to a wall-like frame column in the ground floor of an eight-story building (damage grade 3)

The frame columns were damaged by shear action. Fig. 15 shows a wall-like column with serious shear damage in the ground floor of an eight-story building.

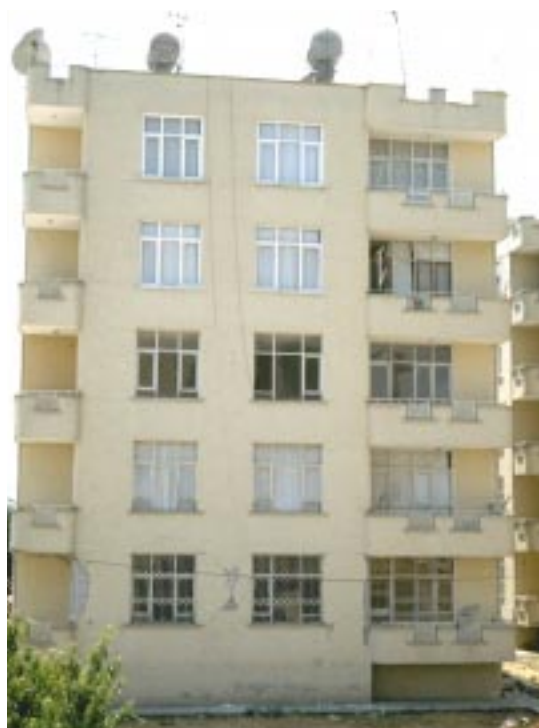
Fig. 16 With few exceptions only the damage is found in the ground floor or in the ground floor and the second floor (damage grade 2)

With few exceptions, most of the damage observed in all inspected buildings was concentrated in the ground floor, or in the ground and the second floor (see Fig. 16). Inspected buildings with a damage grade of 4 or 5 showed relatively intact upper stories while often the ground floor was totally destroyed (Fig. 17 and Fig. 19). Explanations for this typical pattern of damage localization in the ground floor are given in Section 5.2.3.

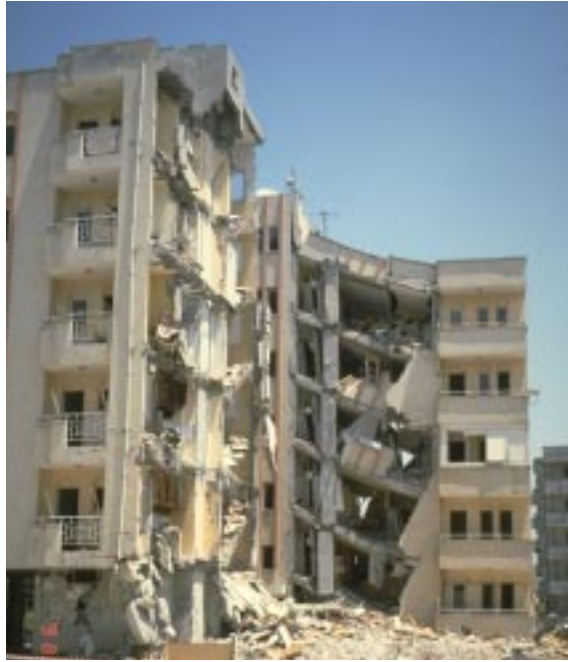
Fig. 17 Partially collapsed residential buildings in the Cumhuriyet Mahallesi district of Ceyhan; one residential building shows a partially collapsed ground floor while the upper floors remained relatively stable (damage grade 4)

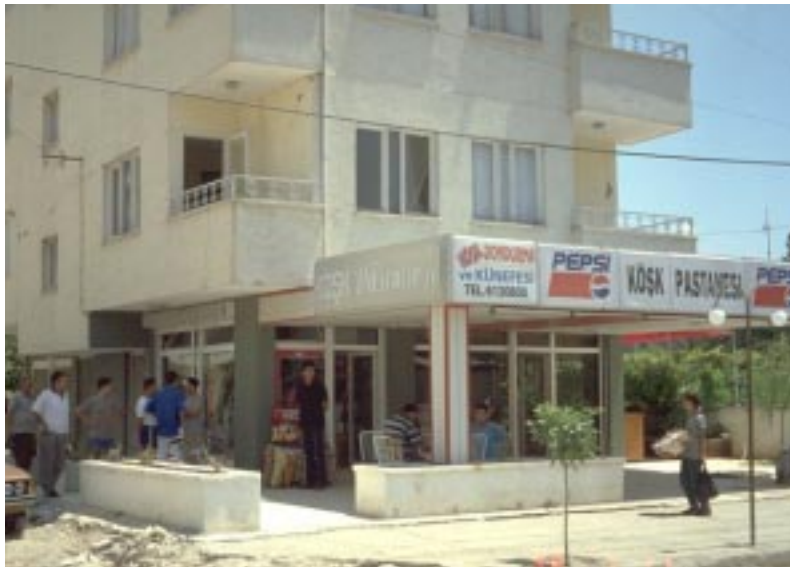
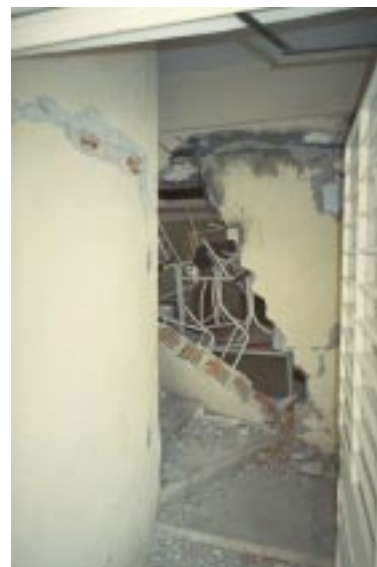
Fig. 18 This building seems nearly undamaged from the outside (left), while the partition walls inside are completely destroyed (damage grade 3)

Often the building damage is not visible from the outside. Such a building is shown in Fig. 18. From the outside, the building seems to be only slightly damaged, while inside several partition walls were totally destroyed. Cracks in other partition walls show that the structural system experienced considerable remaining deformations.

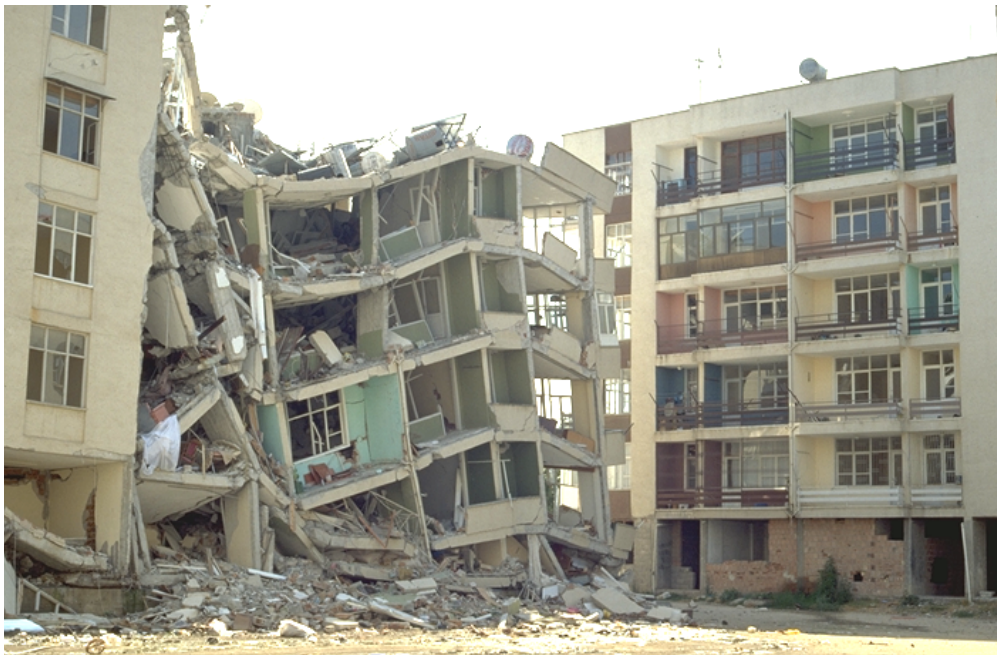
Fig. 19 shows two adjacent residential buildings in the Ceyhan suburbs with very different damage. The ground floor of the building on the left side has completely collapsed (damage grade 5). The damage to the building on the right side was limited to some shear cracks in structural reinforced concrete walls and damage to nonstructural masonry infills (damage grade 3). The two buildings have a lot of similarities: both buildings have six stories, are about the same age, have similar configurations in plan, and have similar facades. It can be assumed that the structural system of both buildings is similar, however their longitudinal axes are perpendicular to each other (Fig. 19). The completely different seismic response of the two buildings may be explained either by directional effects of the ground motion or by different configurations of the masonry infill walls in the first story. The addition or elimination of infills may have resulted in an irregular stiffness distribution with the consequence of localized overloading of certain reinforced concrete columns.

Fig. 19 Two adjacent similar buildings with very different damage pattern. The building on the left totally collapsed in the ground floor (damage grade 5) while the building on the right has slightly to moderately damaged structural walls and masonry infills (damage grade 3)

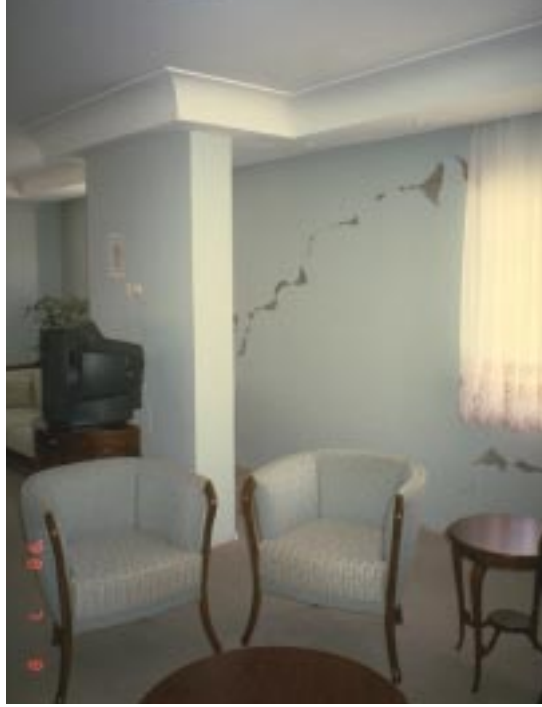
Fig. 20 Damaged masonry infill in the second story of Hotel Takav, a reinforced concrete frame building in Adana (damage grade 1)

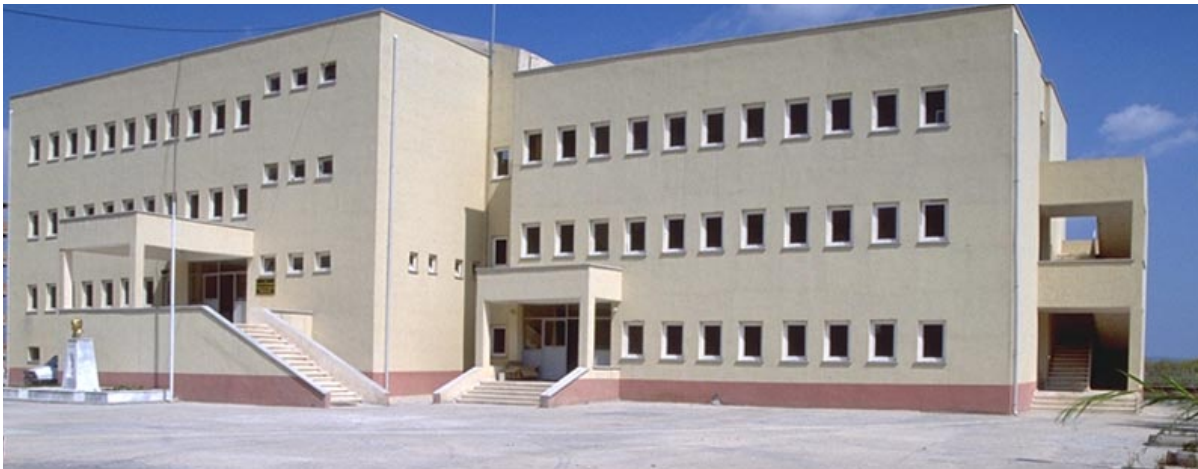
Fig. 21 Undamaged new technical school building in the Cumhuriyet Mahallesi district of Ceyhan

heavy damage including collapse (Fig. 33). The school building consists of a reinforced concrete frame with masonry infill walls. The columns were connected by deep beams in contrast to the residential buildings where the beams were, in general, integrated in the slab (see Section 5.4). The cross sections of the columns in the school buildings were also larger even though the bay width was about the same as in the residential buildings. The infill walls had smaller openings. No damage to the reinforced concrete elements nor to the infills could be found in the school building (Fig. 21). The seismic performance of this school building was excellent.

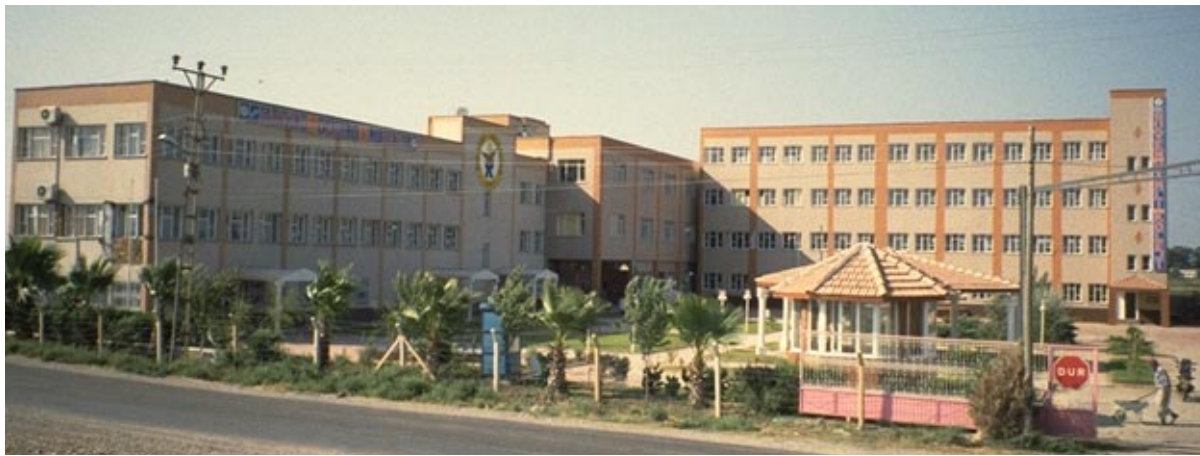
The second school, consisting of three separate buildings, is situated about 1 km west of Ceyhan (Fig. 22). The buildings were constructed about five years ago in a manner similar to the residential buildings, with comparable cross sections and span width. Two of the buildings have three stories and the third has four stories. The two three-story buildings suffered substantial damage (grade 3) and the four-story building moderate damage (grade 2). The columns of one three-story building suffered

Fig. 22 School buildings west of Ceyhan with damage of grade 2 to 3

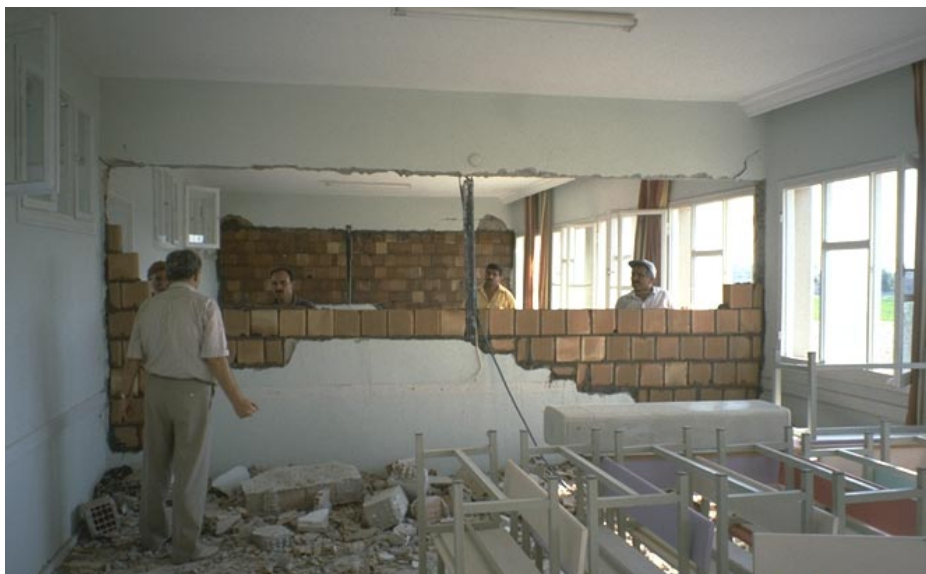
Fig. 23 School buildings west of Ceyhan: Reconstruction of a destroyed masonry infill wall

substantial damage. This building was initially constructed as two stories; the third story was later added. The other three-story building suffered only slight structural damage, but several infill walls were totally destroyed. The remaining lower part of the masonry infill in Fig. 23 has the shape of a triangle formed by diagonal shear cracks. The reinforced concrete beam can be seen above the location of the missing infill wall; the beam and the columns seem to have performed well during the earthquake. As seen in Fig. 23, the reconstruction of the unreinforced infill wall is already under way in the same unsatisfactory manner as previously constructed.

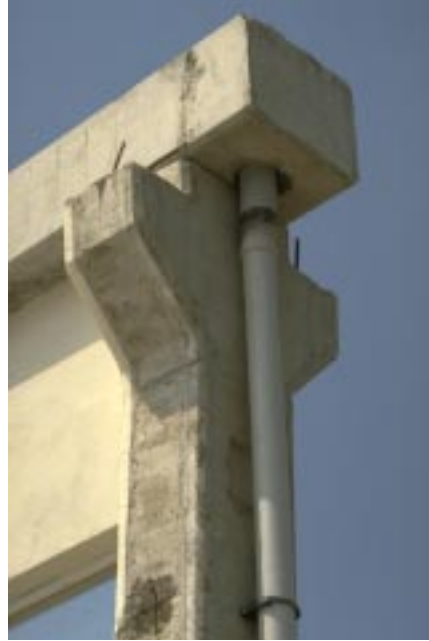
One factory building (Onur tekstil) measured 66 m wide and 130 m long. Its roof is carried by a number of three-span frames. Of a total of 45 beams, three fell off their supports and destroyed the equipment

*Fig. 25 Column top of precast pin-connected frame;
the roof beam fell off the left column corbel*

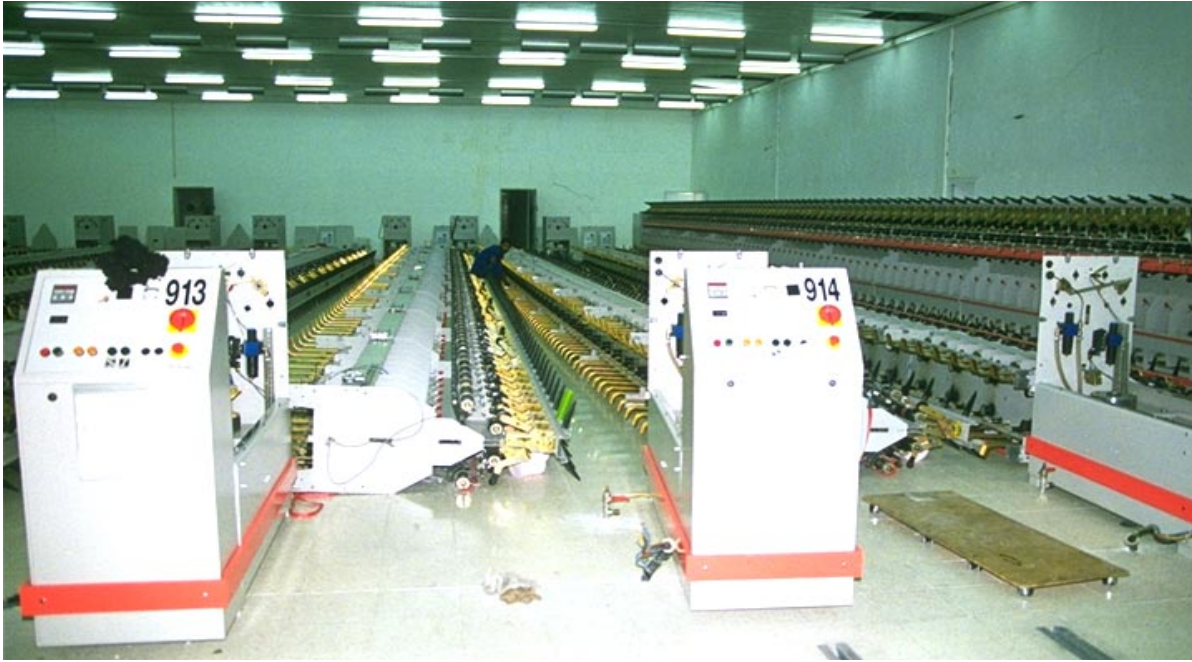
At two industrial sites, roof collapses were observed which destroyed the equipment below and terminated production. The equipment was not only damaged indirectly by collapsed building elements but also directly by the seismic excitation of the ground. In most places, the machinery was in disarray from the earthquake shaking. Spinning machines shown in Fig. 26 even toppled. The loss of production will probably cost much more than the repair of the building damage.

Fig. 26 Toppled spinning machines caused directly by the earthquake shaking interrupted production for several weeks

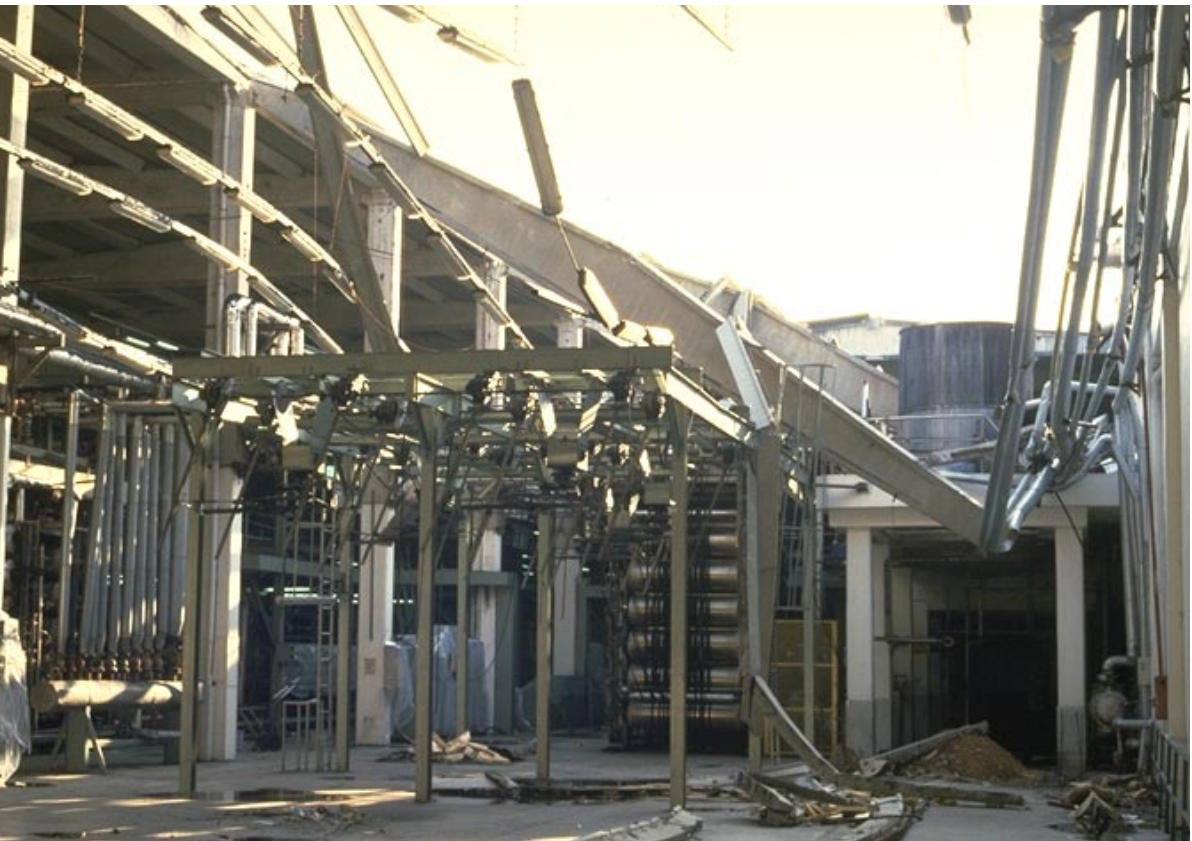
Two weeks after the earthquake, the production in the Onur tekstil company had still not resumed. The repair work of the roof was in progress. In the Bossa Denim company, a relatively small part of the roof collapsed and destroyed one of two dye work production lines completely (Fig. 27). A total repair time of several months is anticipated by the company.

Fig. 27 The collapsed roof destroyed one of two dye work production lines (damage grade 4)

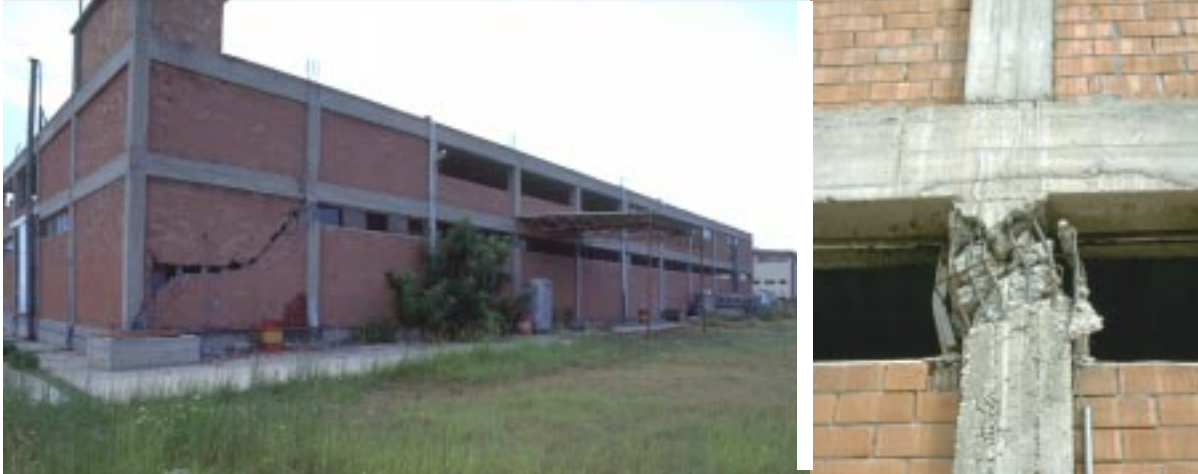
Fig. 28 Two story concrete frame building with partial masonry infill (left), detail of shear failure of reinforced concrete column by the short-column effect (right), (damage grade 3)

A carpet company occupied a cast-in-place two-story frame building with masonry infills. The building suffered substantial damage in the first story. All bays of the first floor except one were partially filled with masonry (Fig. 28). The masonry infill completely changed the failure mechanism of the reinforced concrete columns. Instead of forming a more ductile frame mechanism with plastic hinges at beam-to-column connections, the columns experienced a brittle shear failure in the short free length left open above the infill (Fig. 28 on the right). This phenomenon is known as short-column effect. The bay with a complete masonry infill wall over the full height of the columns (shown in the foreground of the left photo in Fig. 28) failed in a different manner. A diagonal crack formed over the full height of the wall.

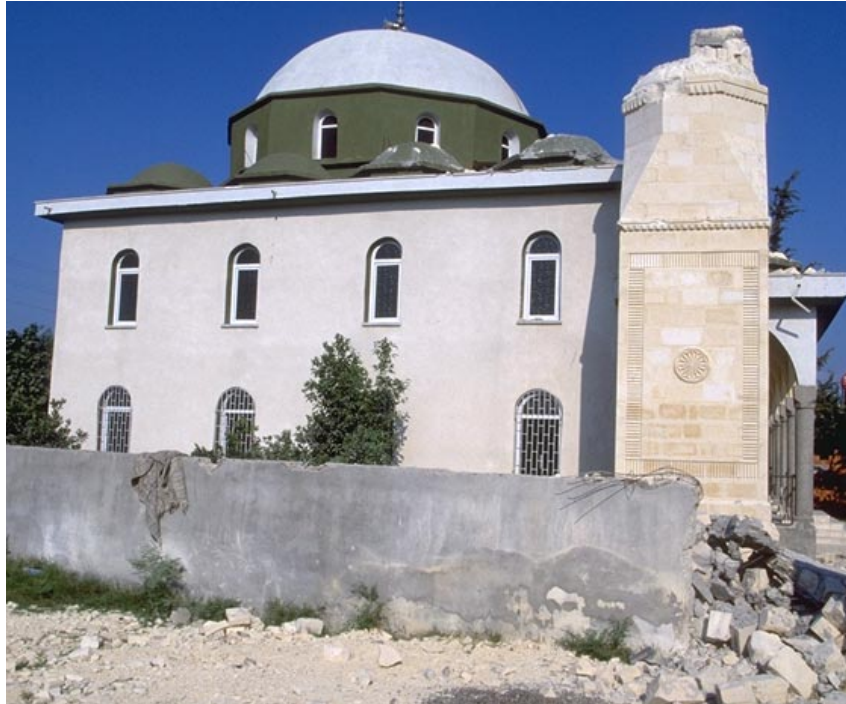
The mosques in the Adana region were usually made from natural stone masonry. About 60 mosques suffered damage from this earthquake (DMC 1998). In general, the main building of the mosque performed well, but the slender minarets collapsed partially or even completely as shown in Fig. 29. In Gecitli the dome of a mosque collapsed.

Fig. 29 Mosque with collapsed minaret in Ceyhan

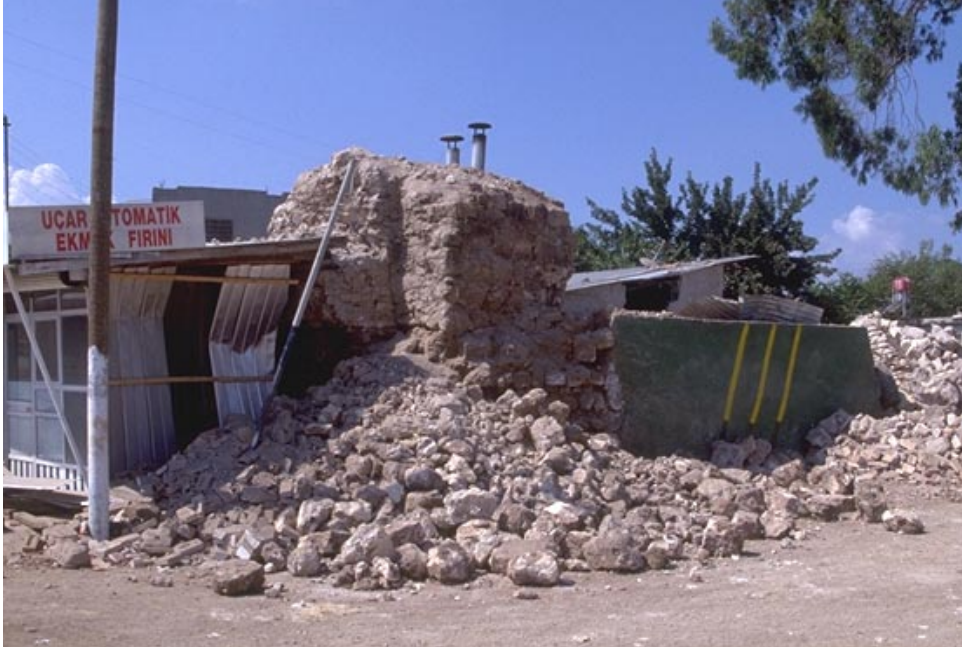
Fig. 30 Destroyed rural building made of field stone masonry in the epicentral area near Gecitli (damage grade 5)

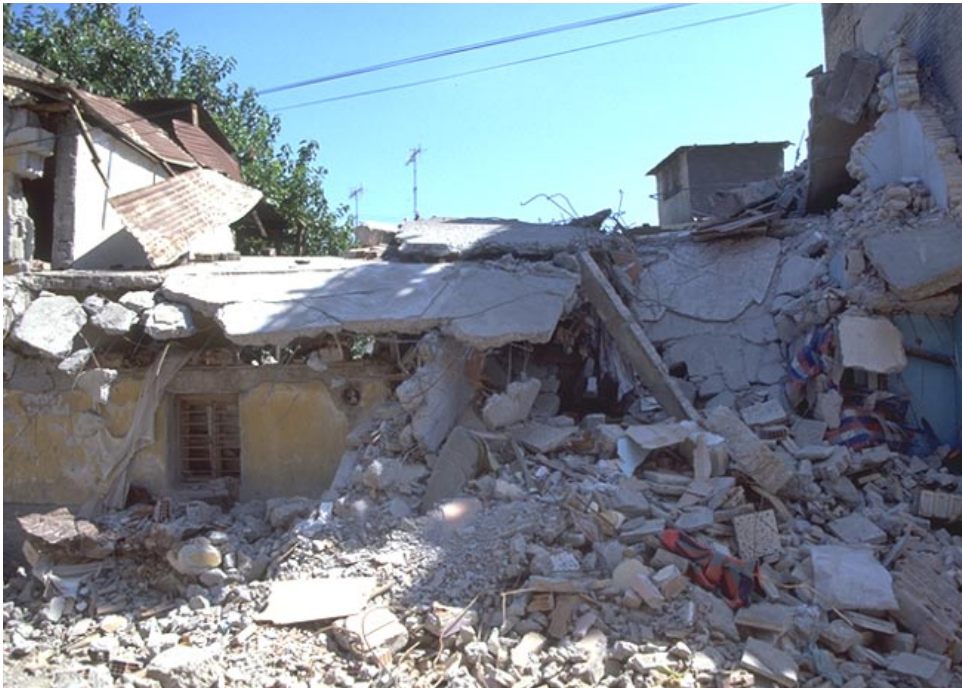
In Adana, there are districts with older traditional buildings made of fieldstone, adobe or brick masonry. Many of these buildings suffered heavy damage, up to damage grade 5. These buildings may be classified into vulnerability class A or B. They possess significantly lower earthquake resistance than the reinforced concrete buildings in Adana and Ceyhan, which may be classified in vulnerability class C (see Section 5.1). As an example, Fig. 31 shows a completely collapsed older two-story building in the center of Adana (damage grade 5).

Fig. 31 Collapsed older masonry building in the center of Adana (damage grade 5)
